Re: Asbestos Ambient Air Monitoring
California State University Los Angeles
King Hall – 2nd Floor – Rooms: D2078, D2078E, & D2708F
5151 State University Dr.
Los Angeles, CA 90032

GETC Project №.: **E225-125**

PROJECT NAME: CSULA - KING HALL - 2ND FLOOR

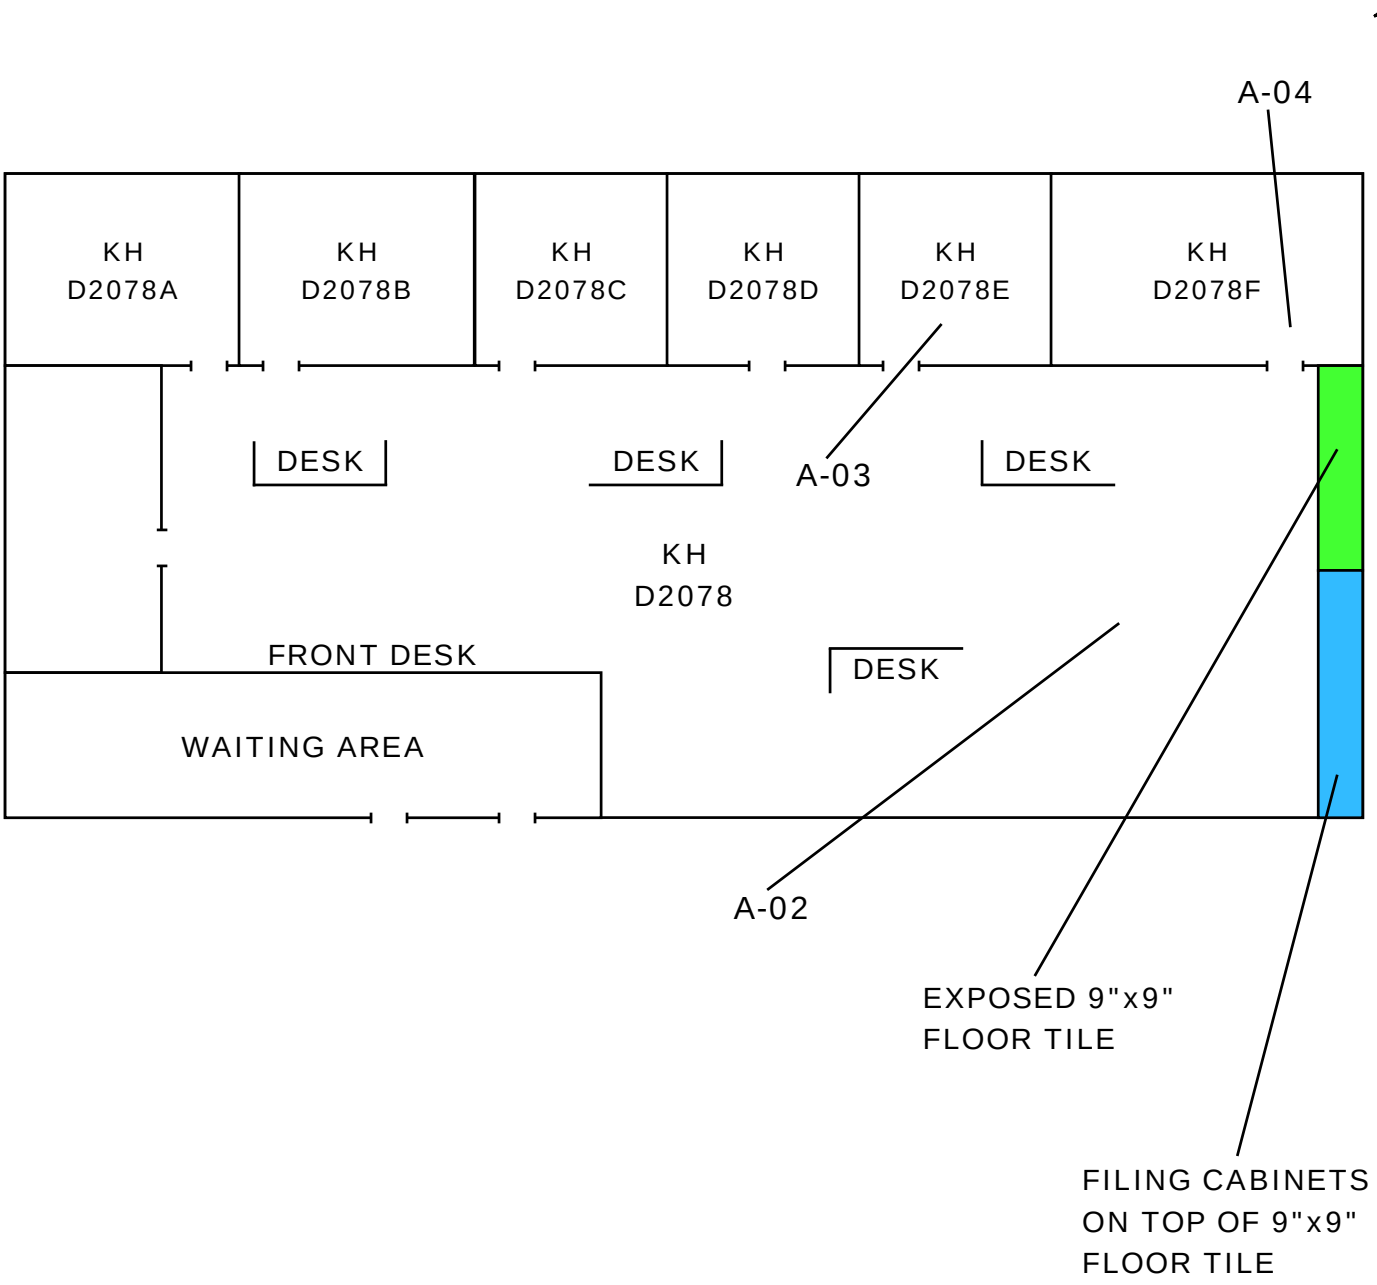
SCHEMATIC

Ambient Air Samples were collected from several areas throughout King Hall – 2nd Floor – Rooms: D2078, D2078E, & D2708F (See diagram for locations). All samples were analyzed using Transmission Electron Microscopy (TEM) using the National Institute of Occupational Safety and Health (NIOSH) Method 7402 which determines specific asbestos structure concentration. The ambient air sample results indicate that Samples #A-03 & #A-04 have no structures detected. However, one (1) Structure of Chrysotile was detected in Sample #A-02 but is below the Environmental Protection Agency (EPA) Clearance Criteria of 70 structures/millimeter squared (70 s/mm²). Area is approved for re-occupancy.
