Re: Asbestos Ambient Air Testing
**King Hall**
**Basement – 5th Floor**
5151 State University Dr.
Los Angeles, CA 90032

GETC Project №.: **E226-024**

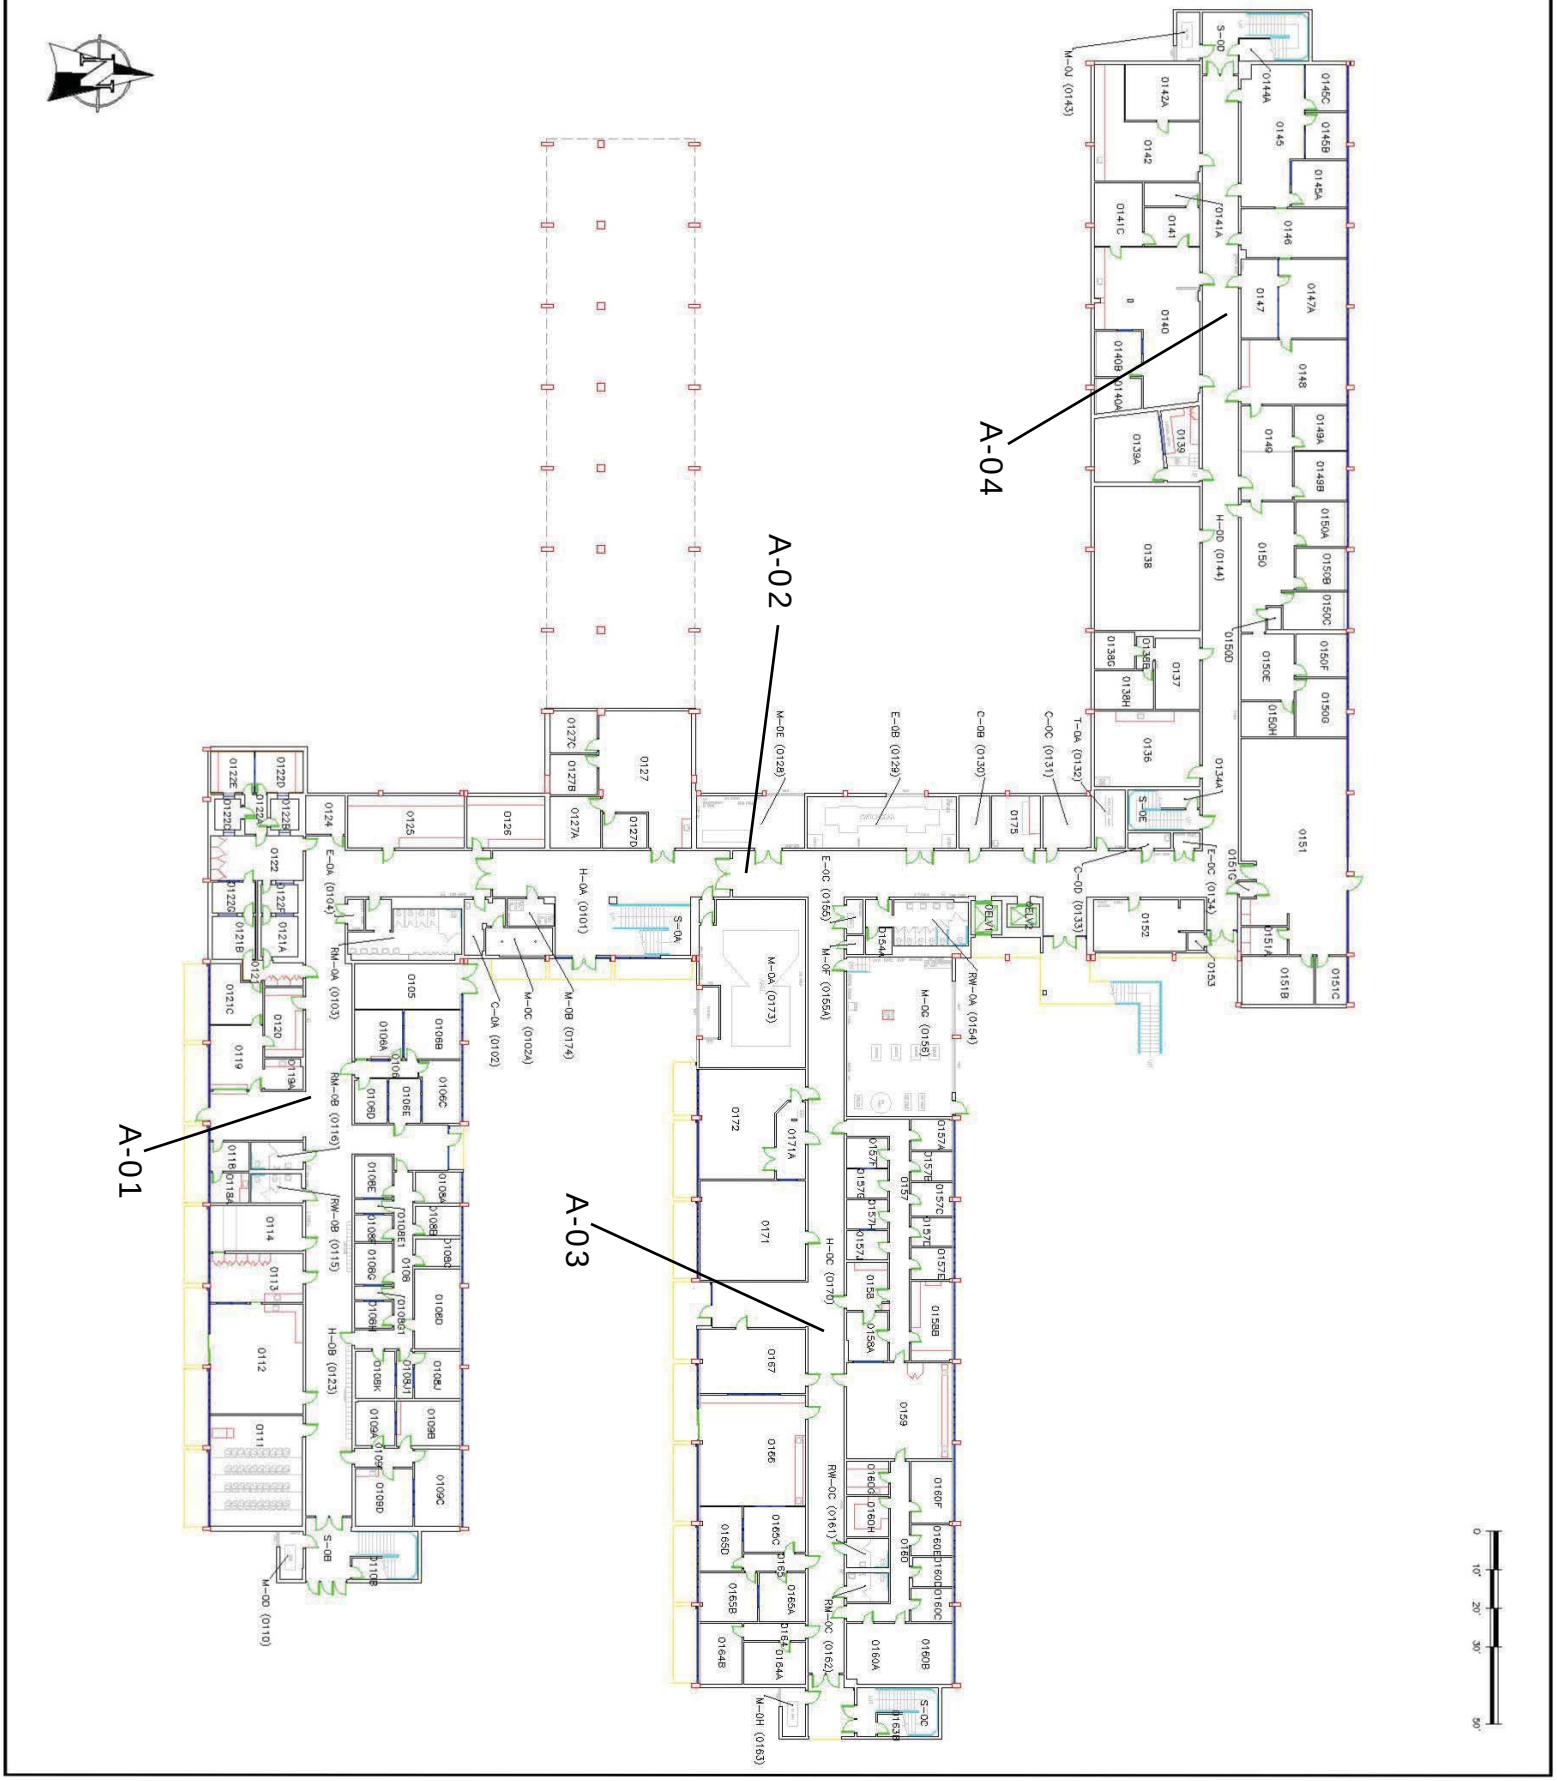
# MARTIN LUTHER KING HALL
## BASEMENT

| SAMPLE № | ACTIVITY CODE | DESCRIPTION / LOCATION | TYPE OF ASBESTOS |
|---|---|---|---|
| A-02 | TEM | Basement – C Wing | NSD |
| **A-03** | **TEM** | **Basement – C Wing** | **ONE (1) CHRYSOTILE STRUCTURE** |
| A-04 | TEM | Basement – D Wing | NSD |

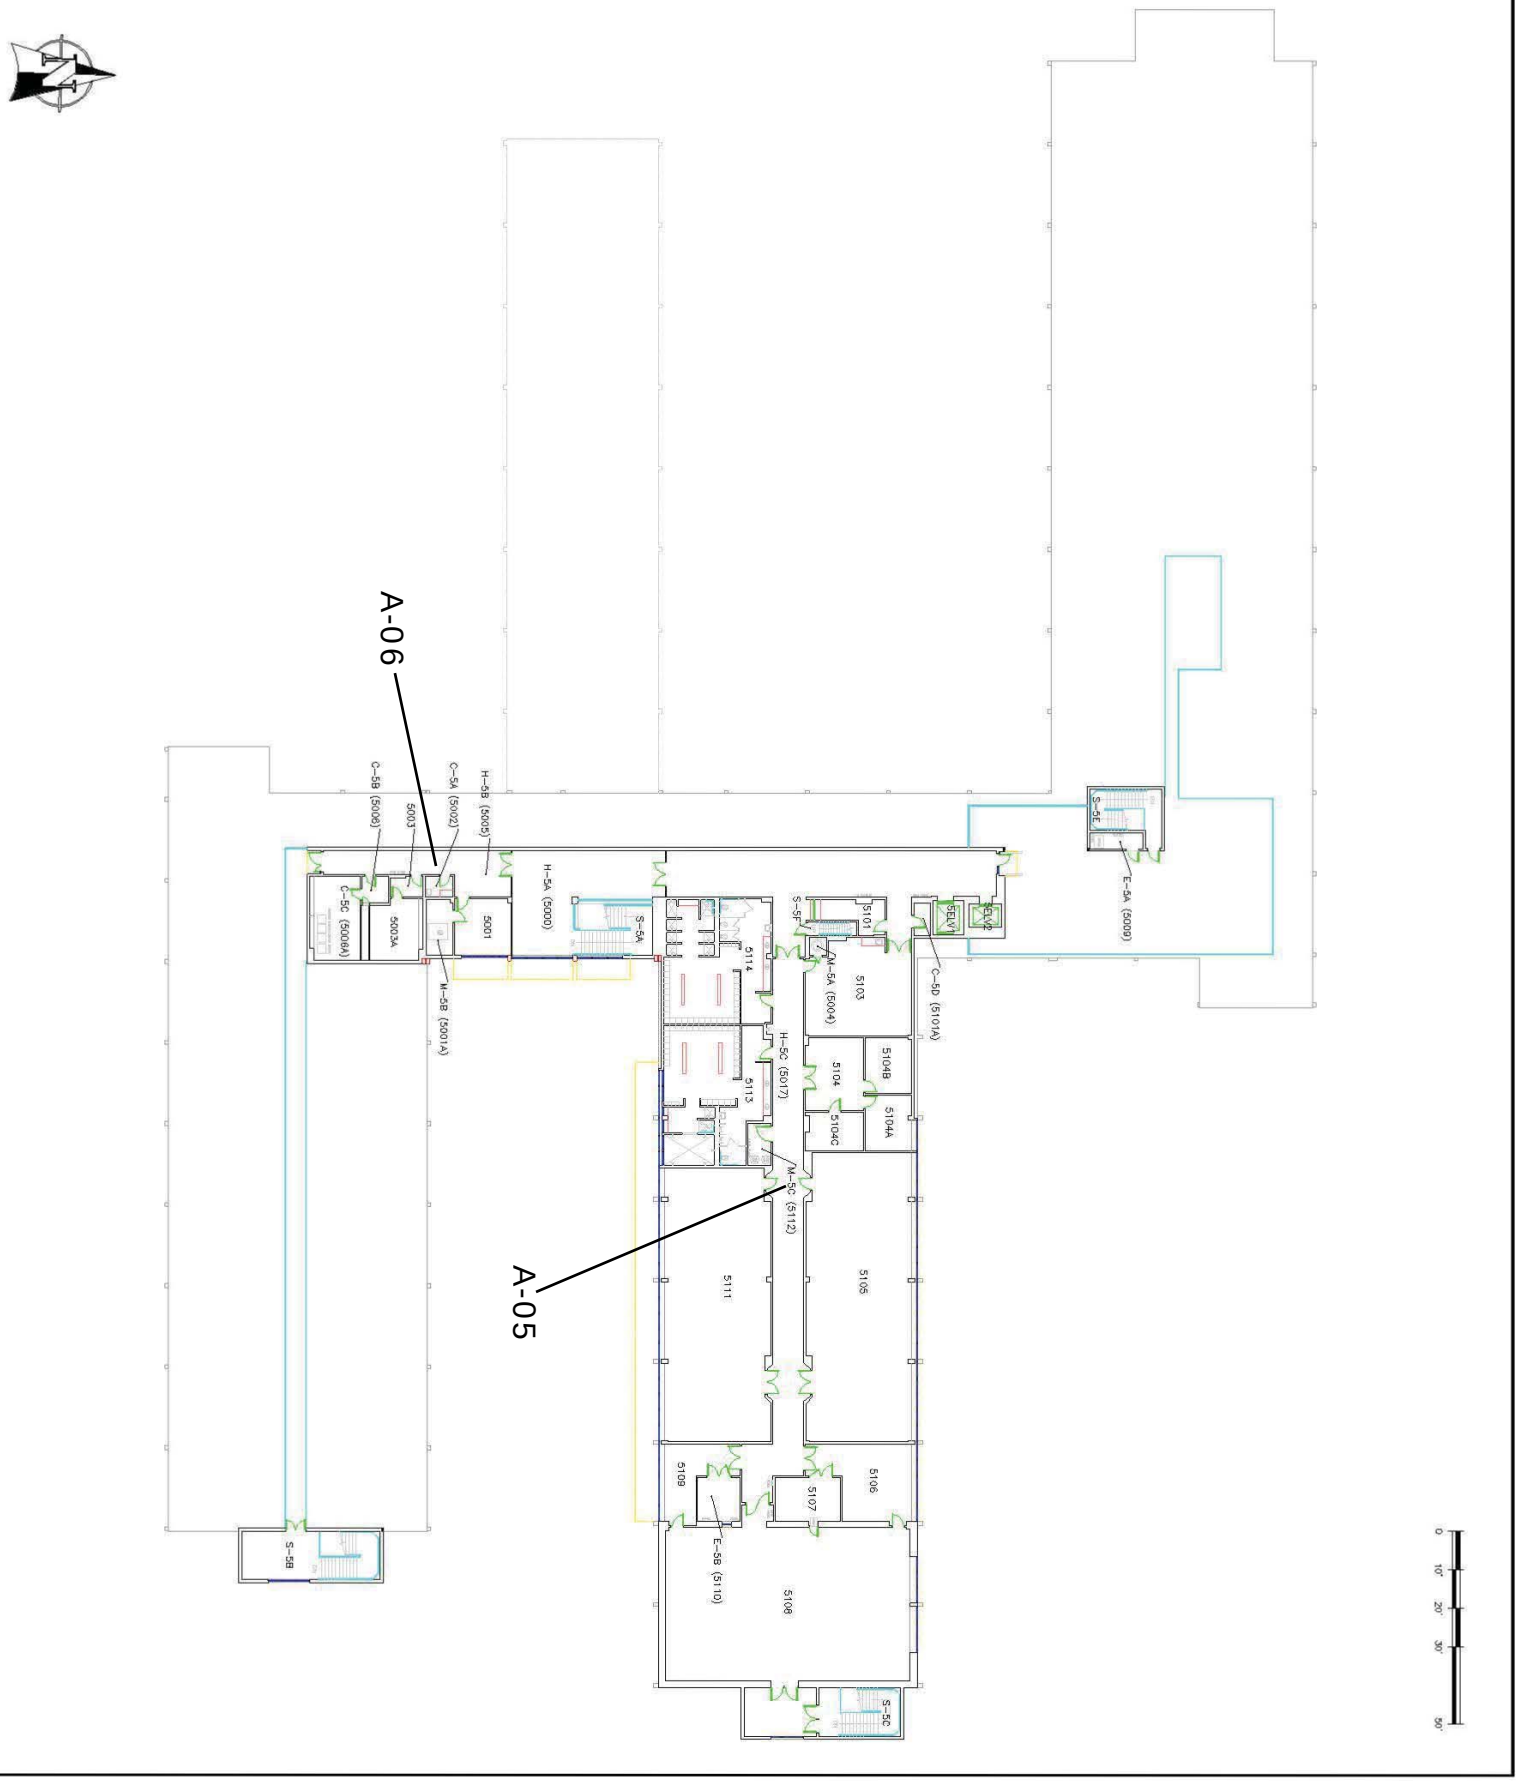
**FIFTH FLOOR**

| SAMPLE № | ACTIVITY CODE | DESCRIPTION / LOCATION | TYPE OF ASBESTOS |
|---|---|---|---|
| A-05 | TEM | 5th Floor – B Wing | NSD |
| A-06 | TEM | 5th Floor – C Wing | NSD |

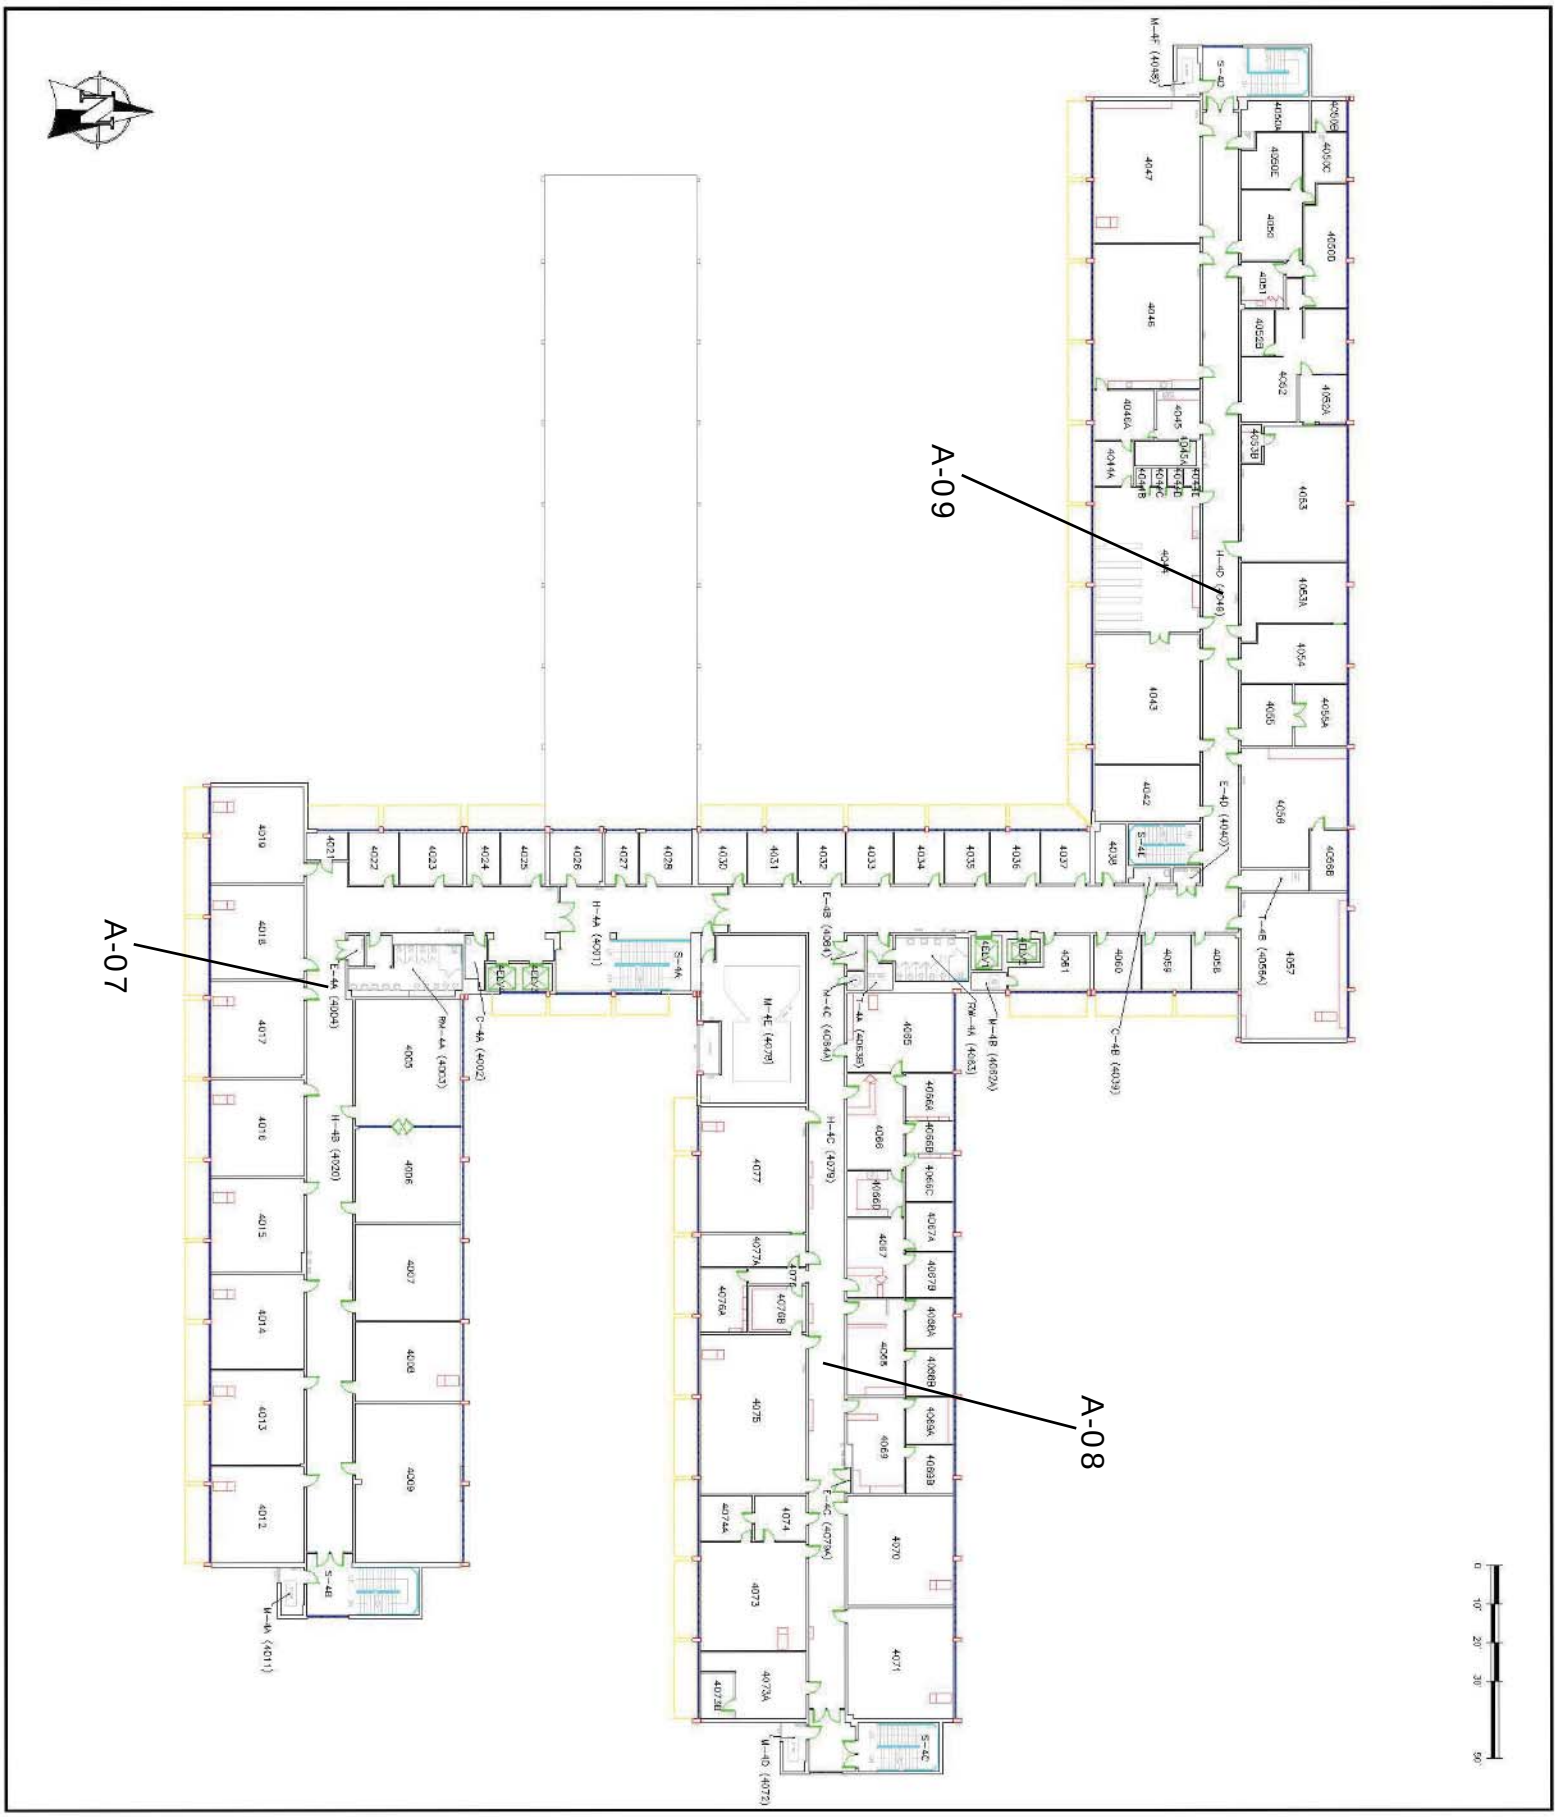
# MARTIN LUTHER KING HALL
## FOURTH FLOOR

| SAMPLE № | ACTIVITY CODE | DESCRIPTION / LOCATION | TYPE OF ASBESTOS |
|---|---|---|---|
| A-07 | TEM | 4th Floor – B Wing | NSD |
| A-08 | TEM | 4th Floor – C Wing | NSD |
| A-09 | TEM | 4th Floor – D Wing | NSD |

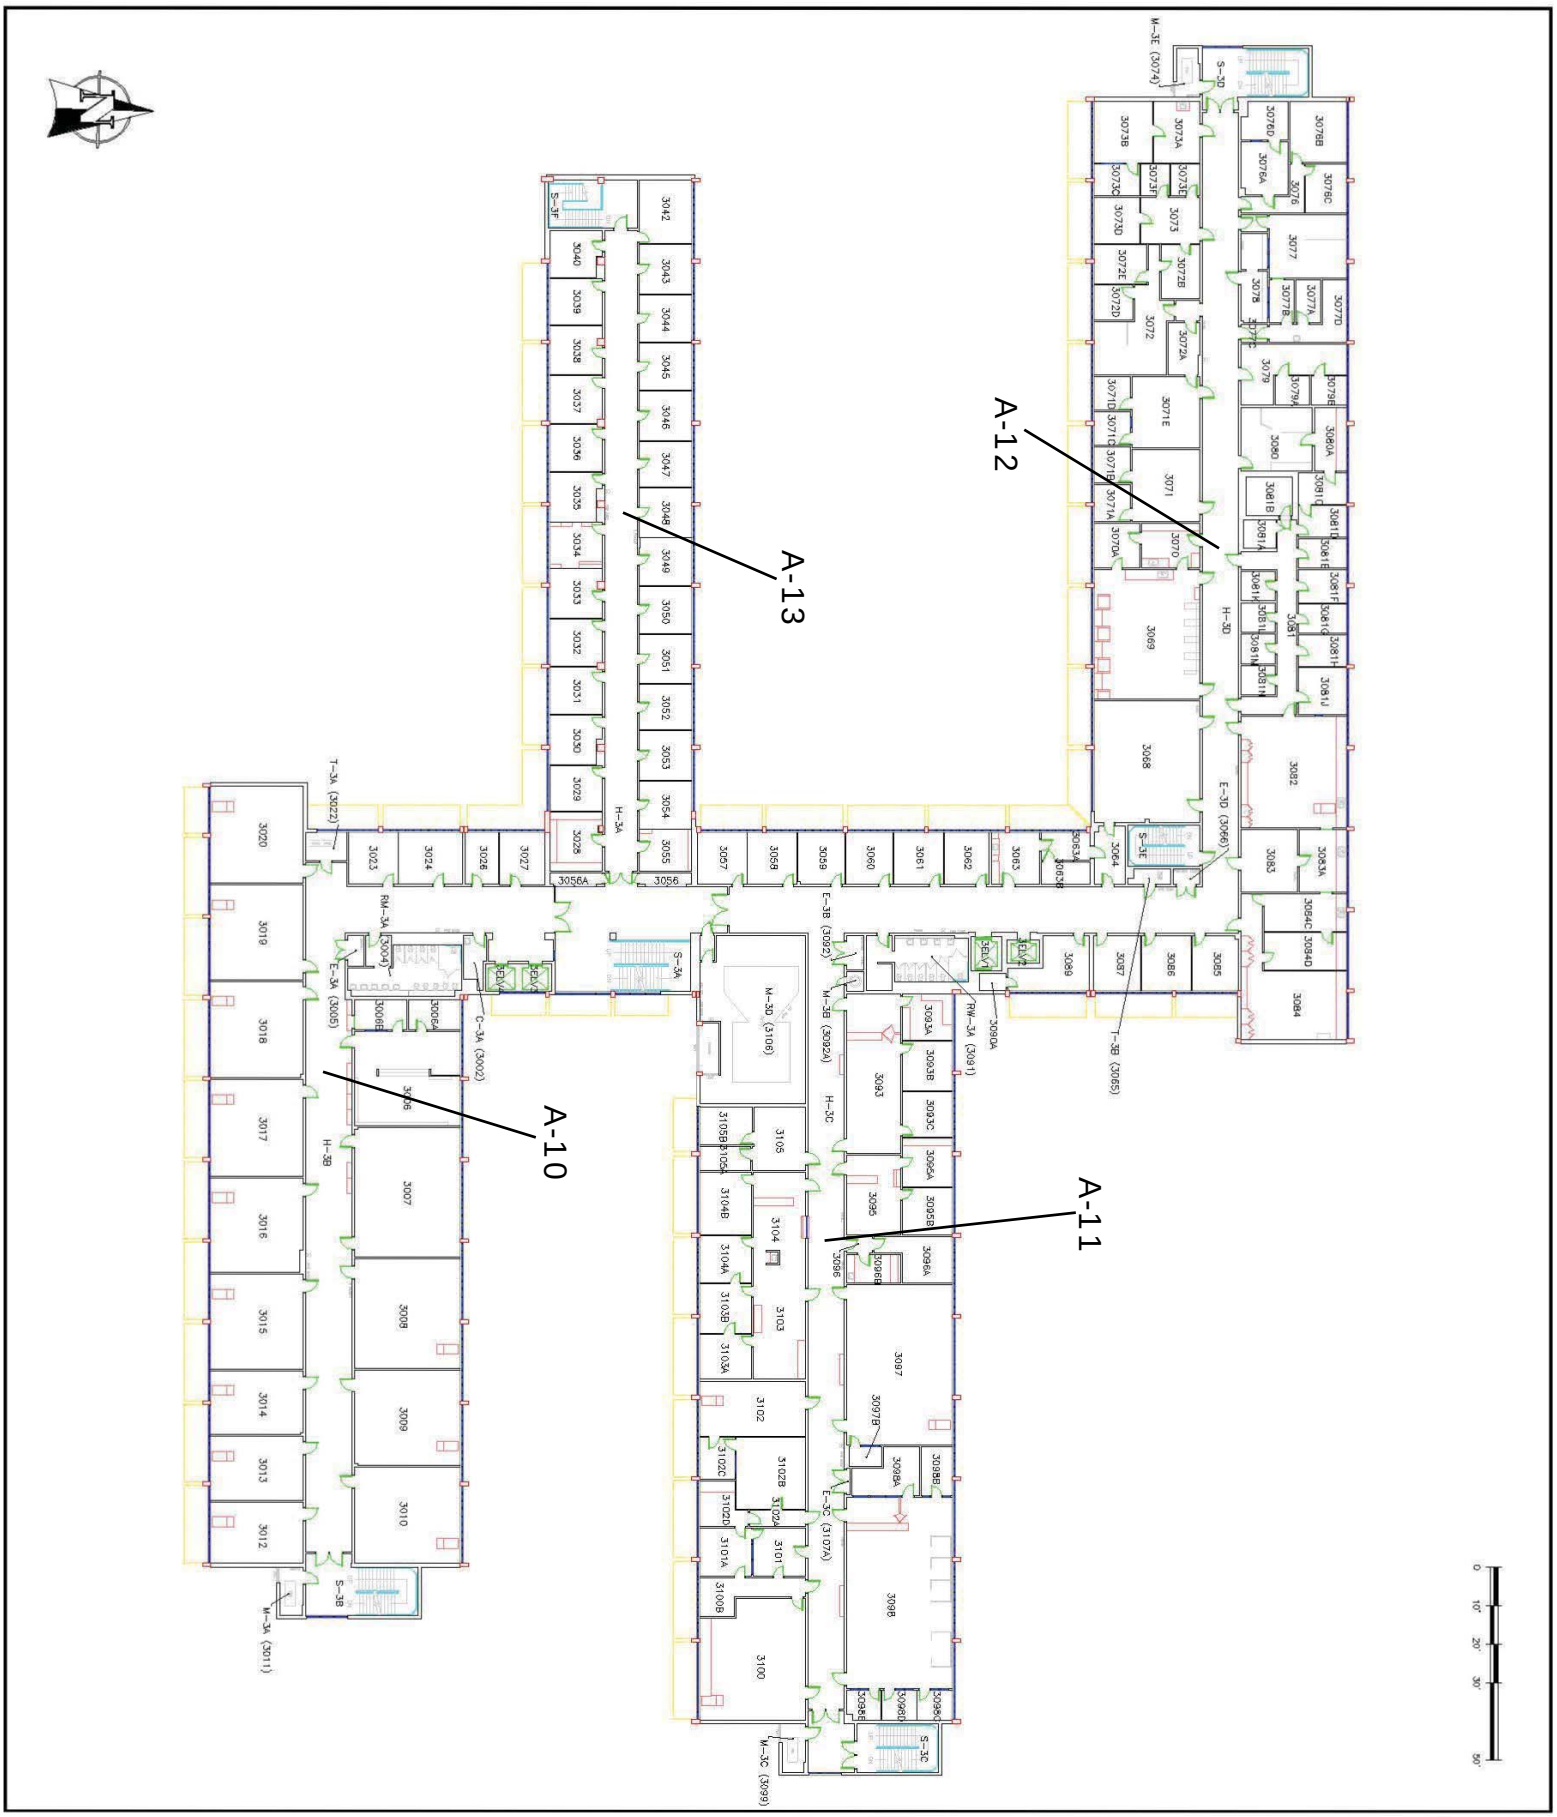
# MARTIN LUTHER KING HALL
## THIRD FLOOR

| SAMPLE № | ACTIVITY CODE | DESCRIPTION / LOCATION | TYPE OF ASBESTOS |
|---|---|---|---|
| A-10 | TEM | 3rd Floor – B Wing | NSD |
| A-11 | TEM | 3rd Floor – C Wing | NSD |
| A-12 | TEM | 3rd Floor – D Wing | NSD |
| A-13 | TEM | 3rd Floor – A Wing | NSD |

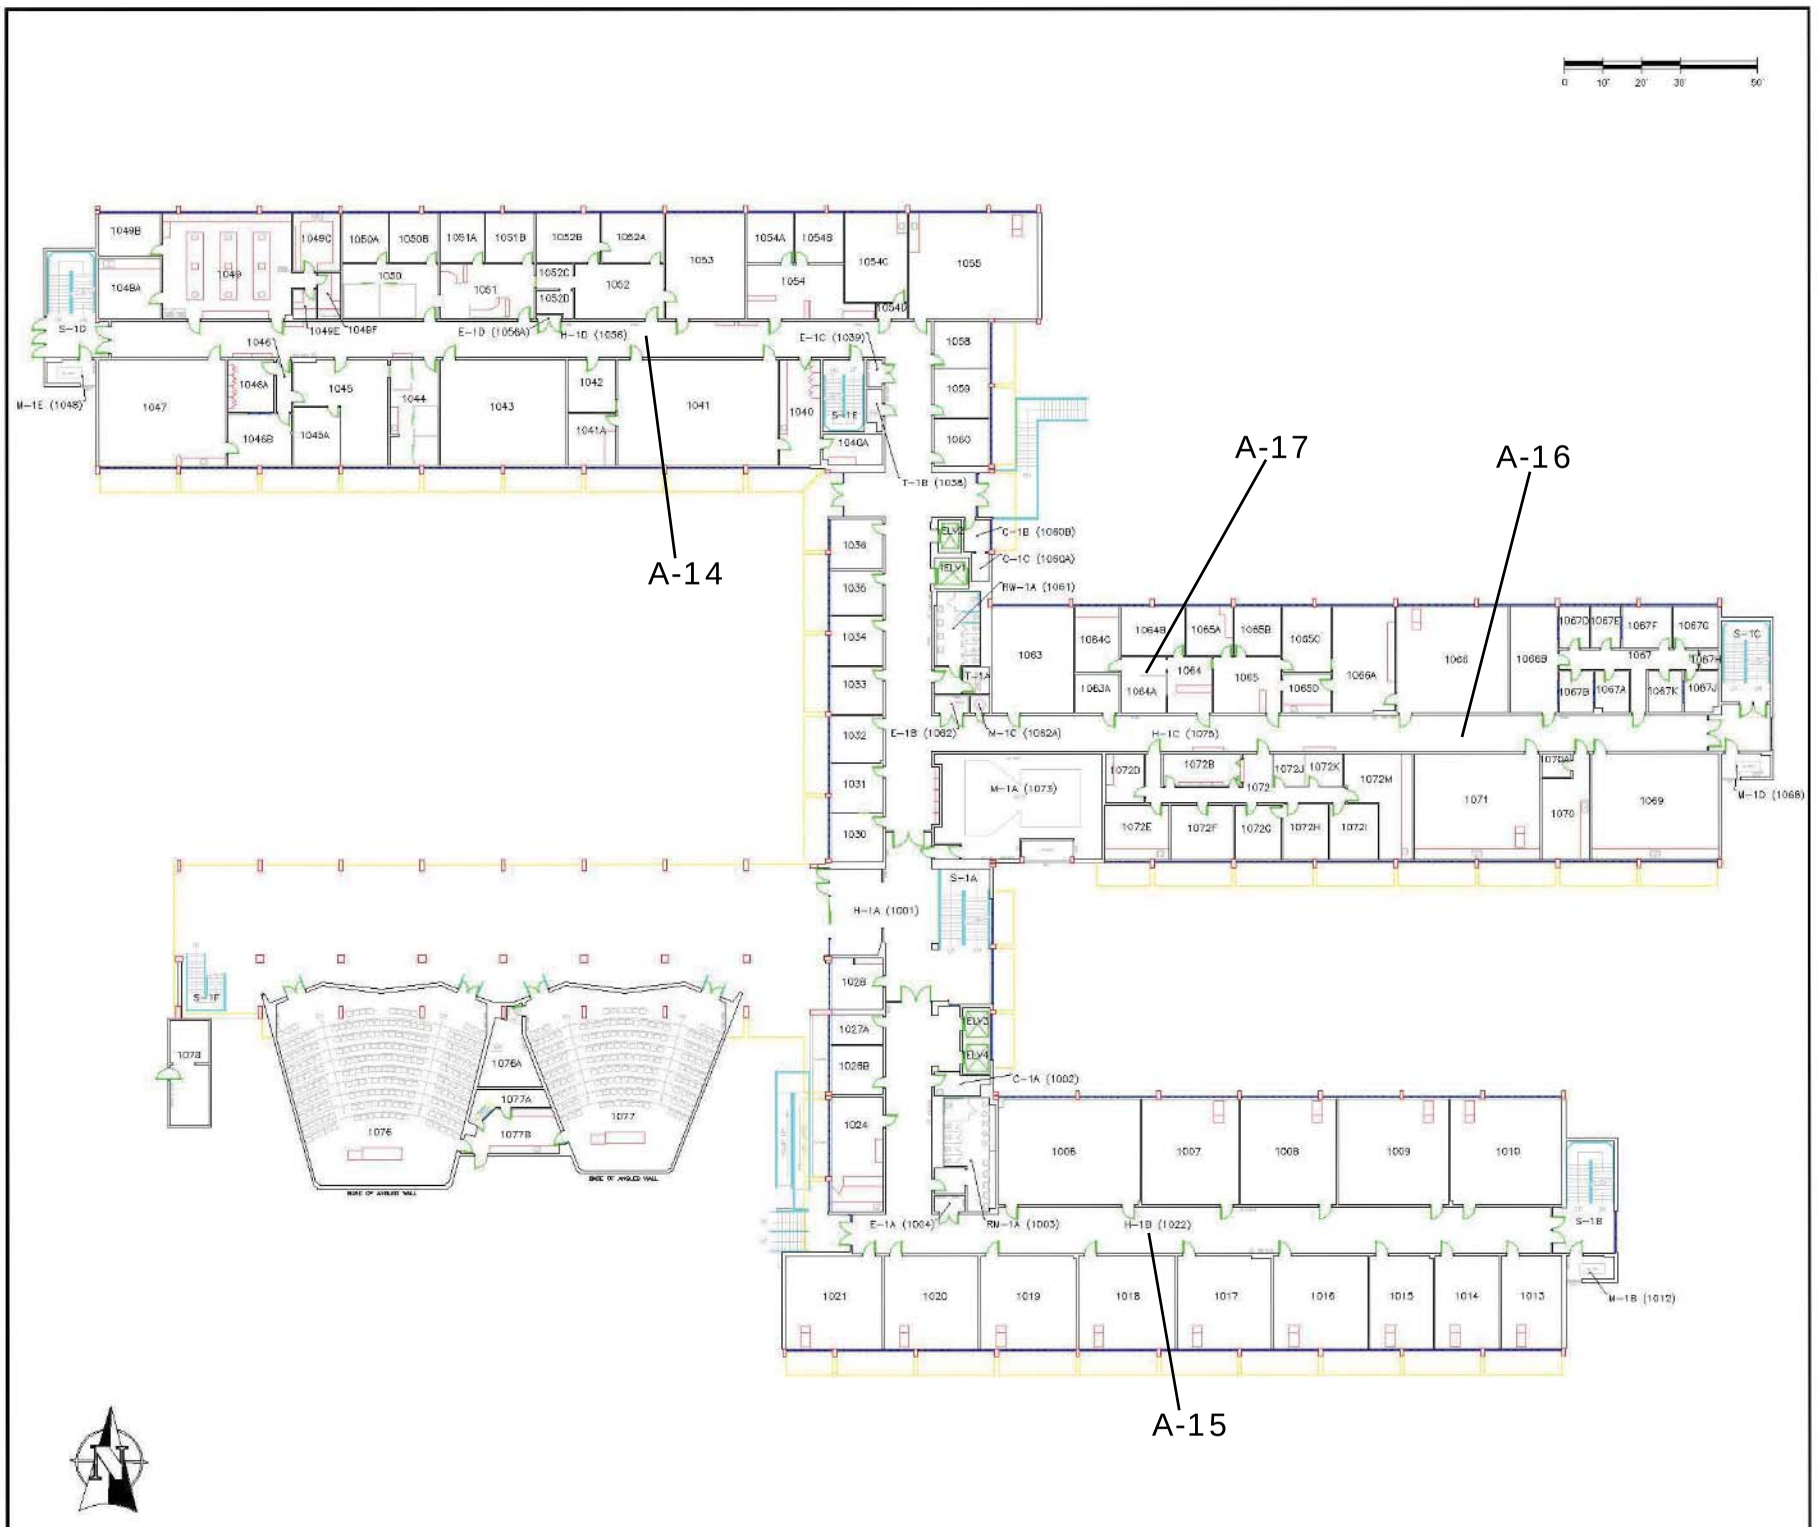
# MARTIN LUTHER KING HALL
## FIRST FLOOR

| SAMPLE № | ACTIVITY CODE | DESCRIPTION / LOCATION | TYPE OF ASBESTOS |
|---|---|---|---|
| A-14 | TEM | 1st Floor – D Wing | NSD |
| A-15 | TEM | 1st Floor – B Wing | NSD |
| A-16 | TEM | 1st Floor – C Wing | NSD |
| A-17 | TEM | 1st Floor – Suite 1064 | NSD |

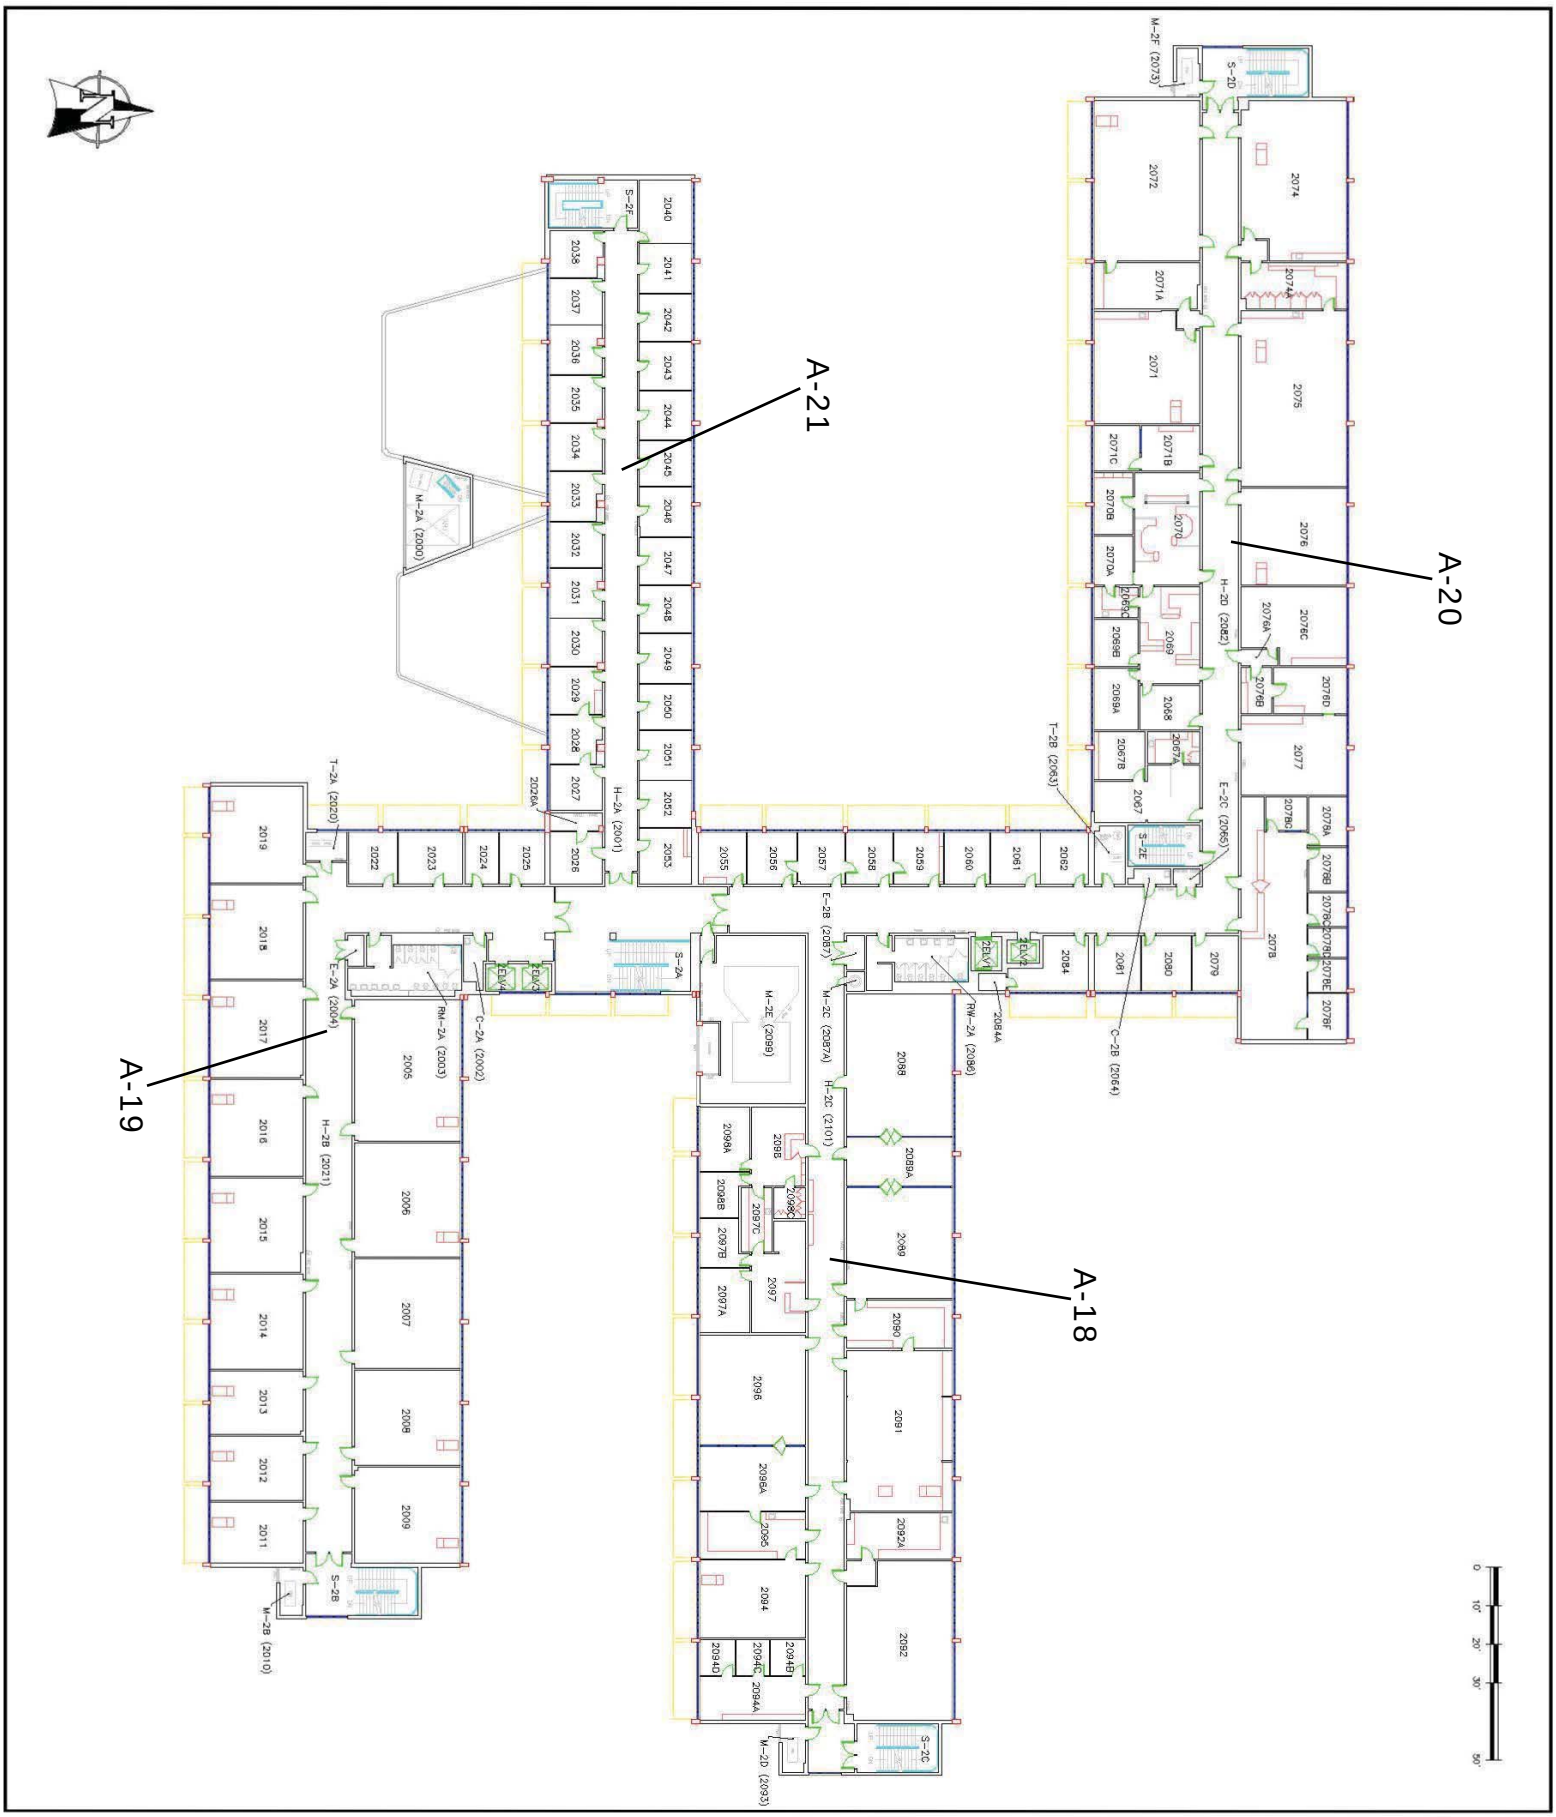
# MARTIN LUTHER KING HALL
## SECOND FLOOR

| SAMPLE № | ACTIVITY CODE | DESCRIPTION / LOCATION | TYPE OF ASBESTOS |
|---|---|---|---|
| A-18 | TEM | 2nd Floor – C Wing | NSD |
| A-19 | TEM | 2nd Floor – B Wing | NSD |
| A-20 | TEM | 2nd Floor – D Wing | NSD |
| A-21 | TEM | 2nd Floor – A Wing | NSD |
